Monitoring Data RecordProject Title: U-4026B (Davis Drive) COE Action ID: 200120448Stream Name: Tributary to Burdens Creek (Site 9) DWQ Number: 051972City, County and other Location Information: Durham County, Davis Drive (Sta. 284+50RT.)Date Construction Completed: 12/5/07 Monitoring Year: (2) of 5Ecoregion: _____ 8 digit HUC unit 03030002

Tributary to Burdens Creek

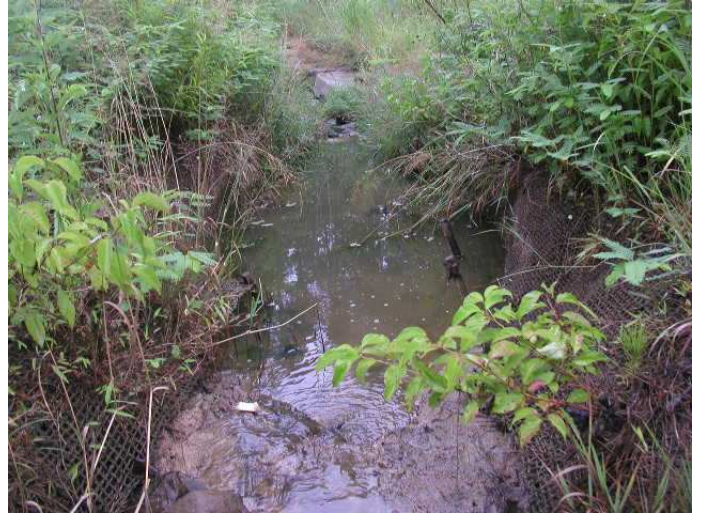
Photo Point #1 (Downstream)

The Tributary to Burdens Creek is stable for Year 2 Summer evaluation, except for two slight headcuts that have formed at Stations 284+50 (Photo Point #1 Downstream) and at Station 285+50. NCDOT personnel met onsite on 5/11/09 to discuss possible options for corrective action. It was decided at that time that corrective action was not necessary and NCDOT would continue to monitor the stream relocation.

| Date Inspected 7/6/09 | Station Number Sta. 284+50 | Station Number Sta. 285+50 | Station Number | Station Number | Station Number |
|--|---|---|---|---|---|
| Head cut or down cut present? | Slight Headcut | Slight Headcut | | | |

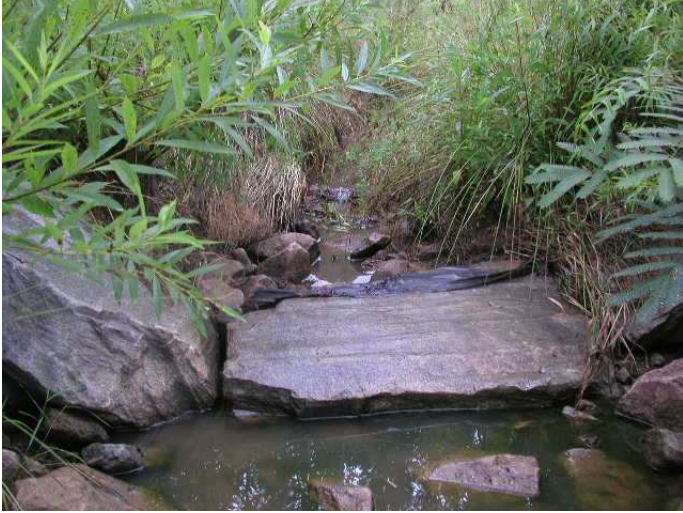
| Date Inspected 7/6/09 | Station Number Sta. 284+50 | Station Number Sta. 285+50 | Station Number | Station Number | Station Number |
|--|---|---|---|---|---|
| Is water piping through or around structure? | | Water is flowing under crossvane | | | |

Water is flowing under a crossvane and a slight headcut has formed at Sta. 285+50 which is downstream of Photo Point #3
